**Re: Response to Comments on Sheet Pile Wall Repair Work Plan
Metal Bank NPL Site, Philadelphia, Pennsylvania, October 2014**

Sheet Pile Wall Repair Work
Plan
Metal Bank Cottman Avenue
Superfund Site

Date:
**November 2014
(Revision #1)**

Re: Sheet Pile Wall Analysis
Metal Bank NPL Site
7301 Milnor Street
Philadelphia, PA 19136

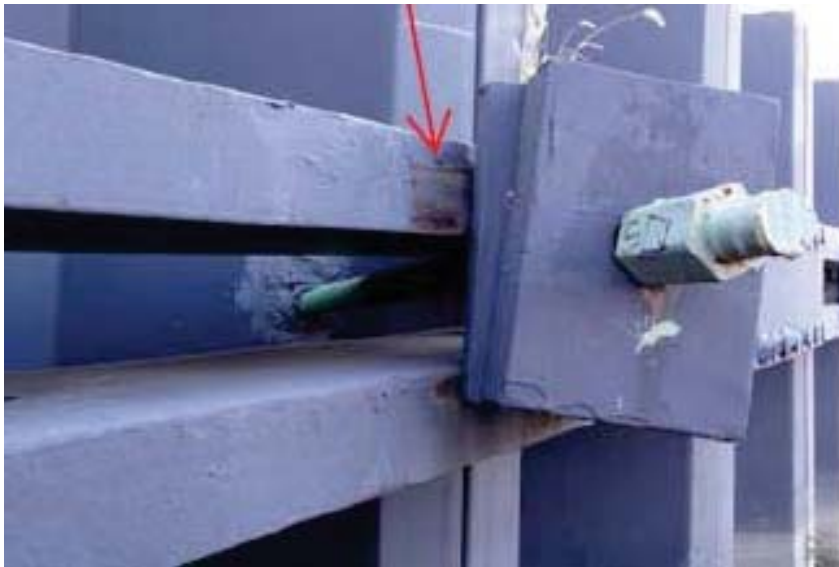
- The north side of Zone 1 shows movement of the sheet pile wall system. The epoxy coating on the face of the wale has been scraped and removed providing evidence that the tieback plates have moved relative to the wale.

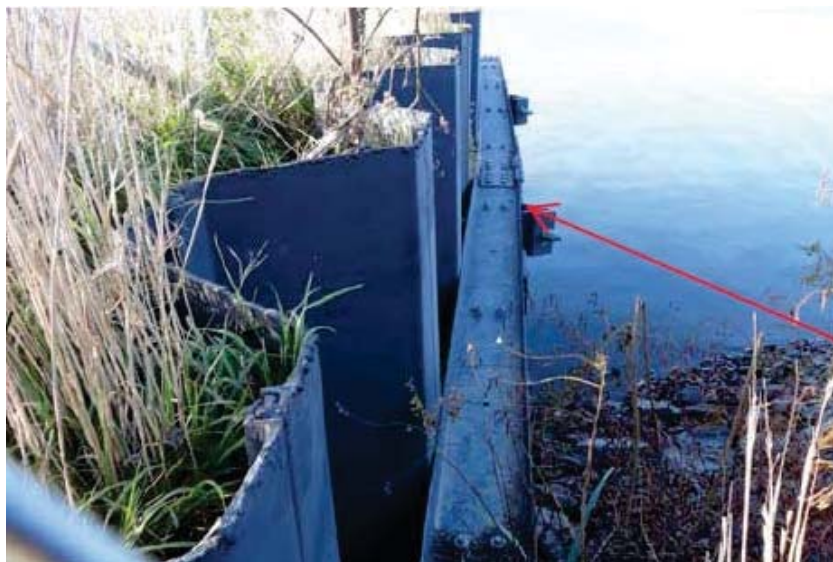
In addition, the wale and sheet pile wall appear to be bowing with the apex of the bow at the bolted connection and there appears to be additional movement of the tieback plates relative to the wale.

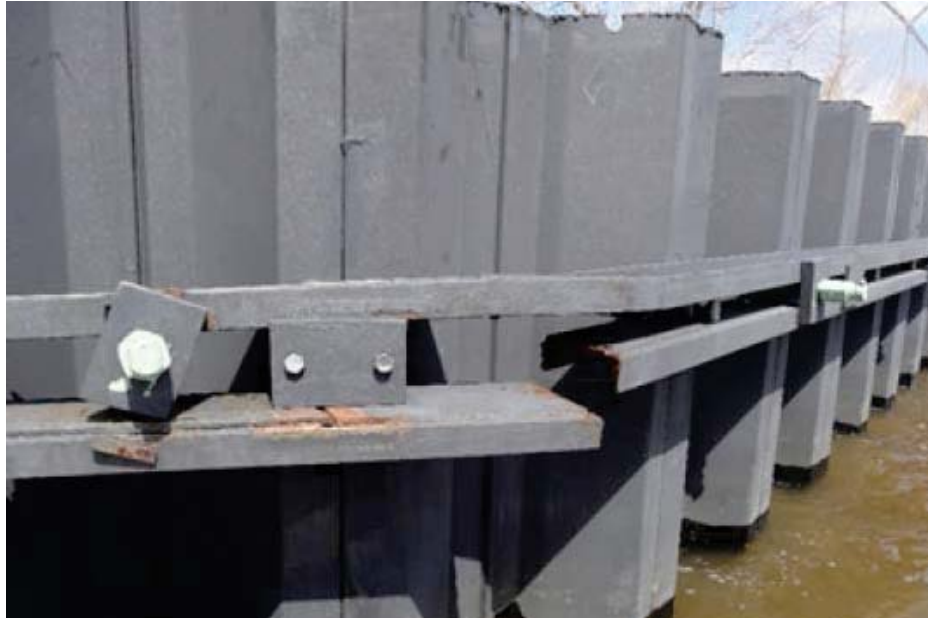
- Cracks and separation of the wale were observed where the sheet pile wall changes direction (turns east) in Zone 2. The miter cut and joint where the wales meet at the corner was cracked. The cracks appear to be stress (tension) cracks. The wale cracked (failed) at this location due to movement of the wall toward the river.

RAC recommends performing the waler repairs after the rip rap has been placed. A schematic of the proposed waler repairs in areas of visible cracks or separation is shown below.

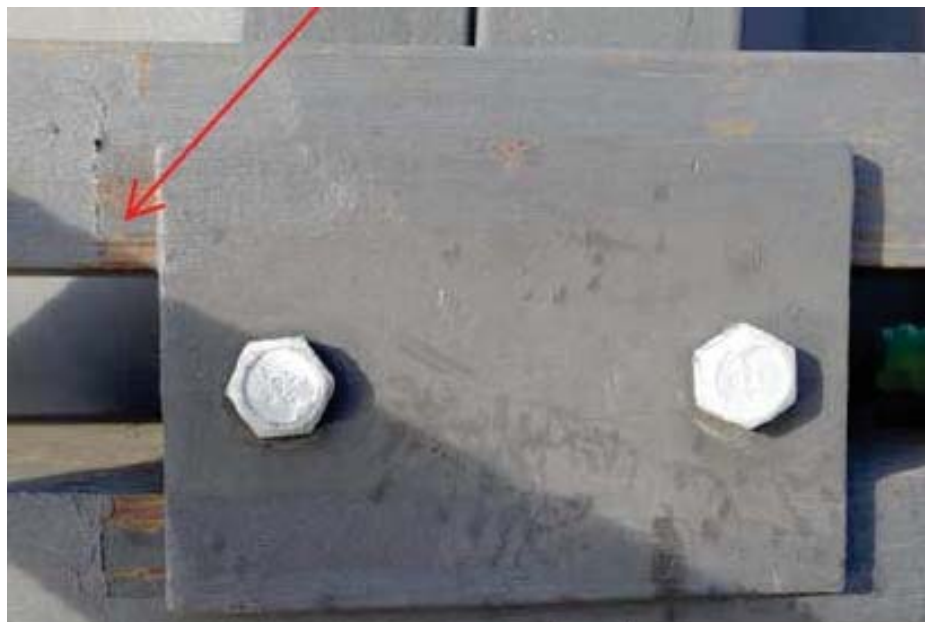
- The west side of Zone 3 shows signs of movement of the sheet pile wall system. The epoxy coating on the face of the wale has been scraped and removed providing evidence that the tieback plates have moved relative to the wale. No landside access to this area. No significant signs of movement observed from the watercraft.

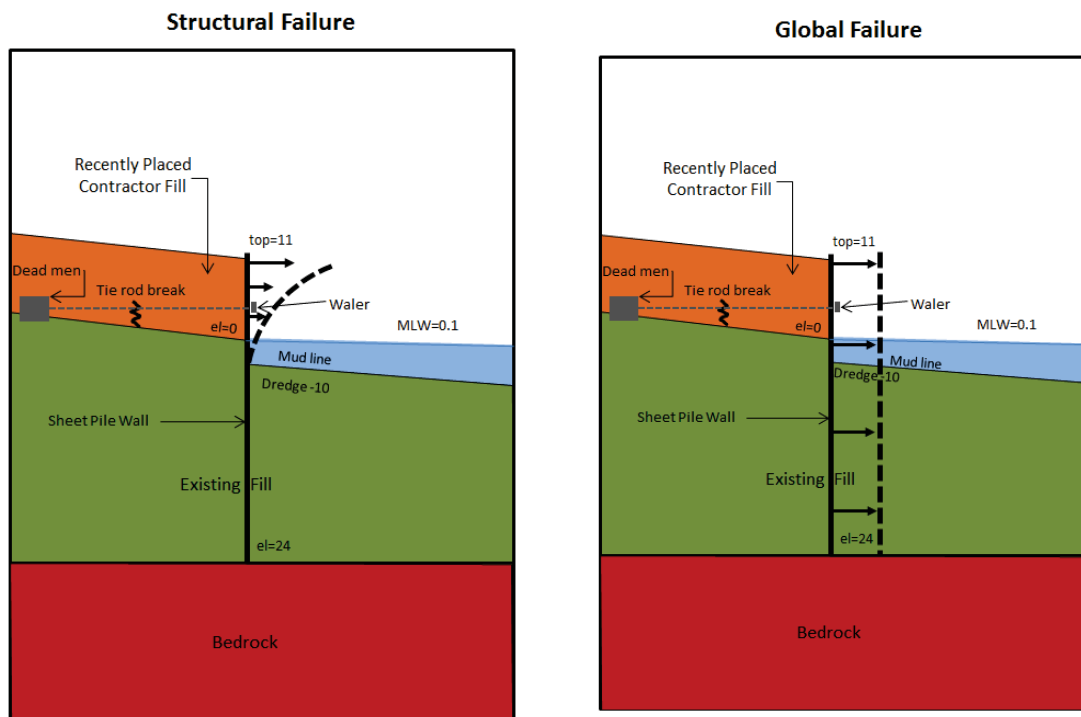
Structural failure describes the movement of the sheet pile wall above the mud line in the direction of the river. Global stability failure describes the overall movement of the sheet pile over the entire length of the wall above and below the mud line in the direction of the river. The two types of failure are represented schematically below.

- High water conditions: The simulated tie-rod loading (114.84 Kips) slightly exceeded the allowable tie-rod loading (108 Kips). The global stability failure envelope extends 38 feet laterally, just 2 feet short of the distance to the dead men (40 feet), providing minimal protection against sliding failure. The sheet pile wall is not materially overstressed and insignificant movement of the wall is anticipated.

- Low water conditions: The simulated tie-rod loading (206.52 Kips) significantly exceeded the allowable tie-rod loading (108 Kips). The global stability failure envelope extends 41 feet laterally, which is beyond the position of the dead men, providing no protection against sliding failure. The sheet pile wall is locally overstressed at the tie-rods and significant movement of the wall is anticipated. The additional stresses under low water conditions are likely a major contributor to the wale failure and movement of Zone 1 return wall observed in the field.

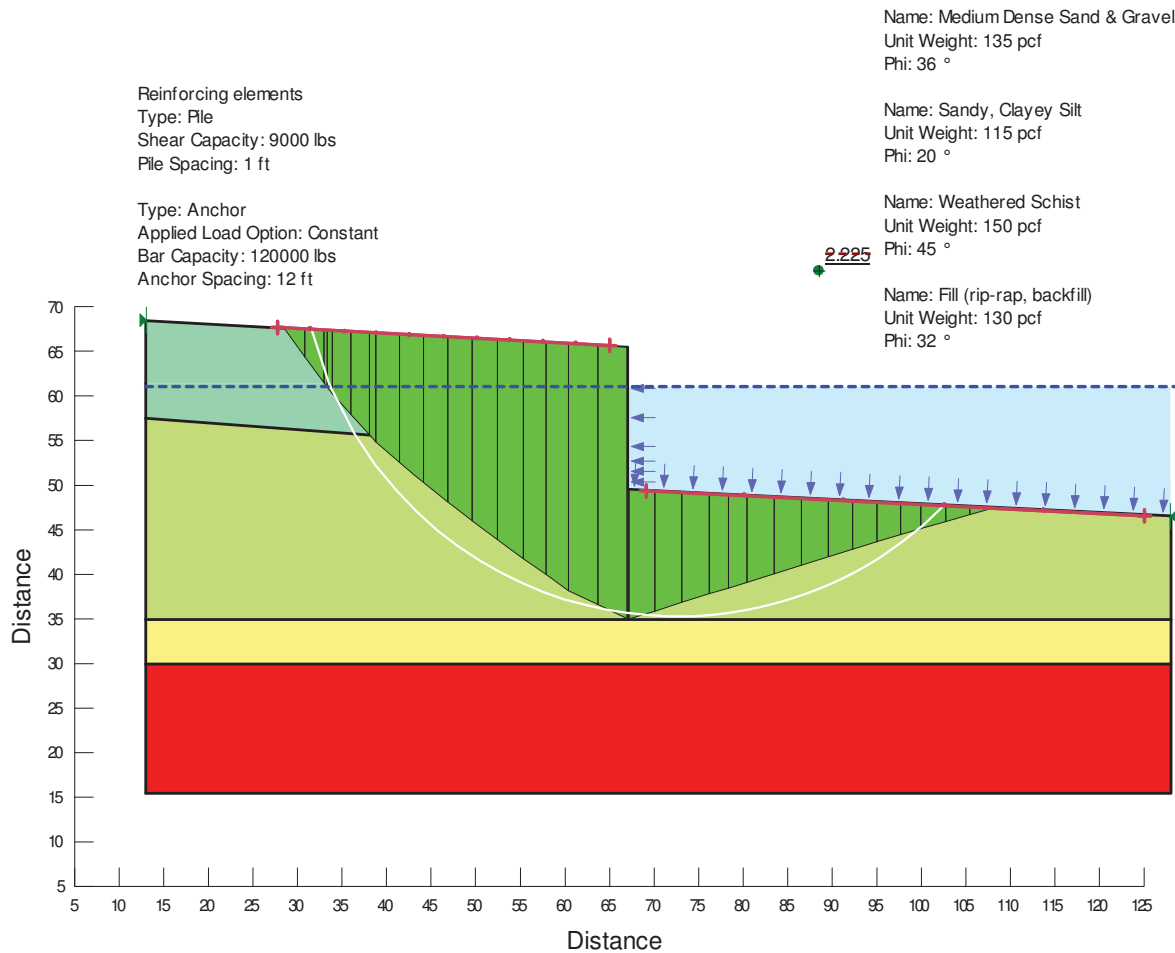
Figure 6 – Analysis Results for Section A

When Analysis Section A was analyzed using SLOPE/W, a FS of 2.225 was calculated against failure (Figure 6). Similarly, Prosheet calculated a required sheet pile penetration of just over 35.5 feet, yielding a FS of 3.335 (Figure 7). The FS calculated in the ProSheet program is a function of the allowable stress available in the sheet pile section selected and maximum stress calculated in the wall section. Also to note is that the calculated required anchor force, 6.33 kips per foot of wall, or approximately 76 kips, is less than the specified 108 kips for this section of wall. This indicates that the anchors are not overstressed.
